Transport
Canada

TP 6980E

Issue 3/2005

Canadian Aviation Service Difficulty Reports

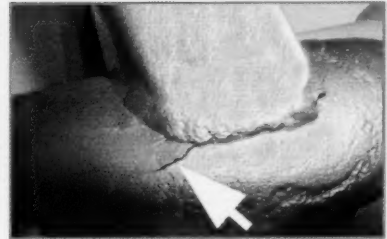
Rudder Torque Tube Cracked

While conducting a scheduled annual inspection, an operator discovered the rudder torque tube assembly, P/N 304201, cracked along the weld.

Keep this in mind. It may be difficult to determine if the weld or an actual part is cracked. Non-destructive testing may be required to confirm the suspected defect. ✖

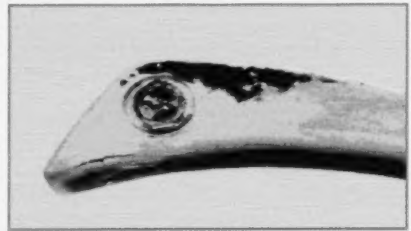
Flap Bracket Cracked

While conducting a routine inspection, a crack was noticed on the left hand inboard flap actuator attachment bracket, 50-16003-6. The bracket was removed and further inspection determined a total of four (4) cracks on the bracket surrounding the upper bolt hole. The flap was also cracked under the forward end of the bracket. The flap was repaired, the bracket replaced and the aircraft was returned to service.

The operator conducted a fleet-wide campaign inspection of this area and discovered the same defect on one other aircraft. This defect may be difficult to detect, disassembly of the flap and flap bracket may be required. ✖

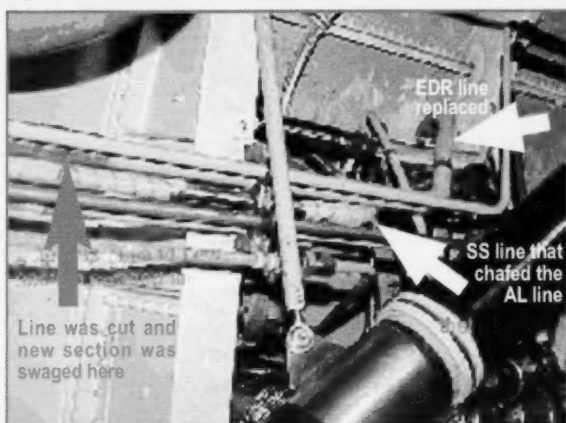
SDR # 20050512002

Hydraulic Lines Chafed

The flight crew reported a hydraulic problem, "HYD 1 LO PRESS" with the quantity indicating - "zero". The flight continued and the aircraft landed on the runway with no further incident. Upon inspection, maintenance personnel found the #1 system suction tube assembly chafed at a point 18" from the forward end.

The suction tube, P/N 601R75286-37, reference IPC 29-11-00, fig 4, item 120, had chafed on the #1 hydraulic system stainless steel pressure line. A segment of new suction line was perm-swaged in position, ensuring proper separation between lines.

The pressure line was inspected and found serviceable, and the #1 engine-driven pump was also replaced.

Recognizing and maintaining proper clearance between these lines could have prevented this from happening. Teflon wrap around one or both lines, in addition to maintaining the proper clearances, could have added additional protection in this close clearance area. AME's are also reminded to wear proper protection when working with Skydrol. ✂

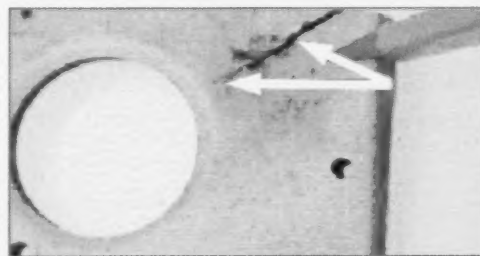
Nose Wheel Steering Bracket Cracked

The operator of a Cessna 550 had multiple nose wheel shimmy defects on his aircraft. After rectifying the defect, the area was inspected for other collateral damage associated with the nose wheel shimmy. Bracket, P/N 556561851, was found cracked. The part was replaced and the aircraft returned to service.

The submitter noted these brackets are prone to cracks and Cessna produced a heavier gauge material bracket as corrective action. The bracket found cracked was of the newer design.

If you have experienced similar defects, i.e. nose wheel shimmy, operators are encouraged to inspect this area for cracked brackets. ✂

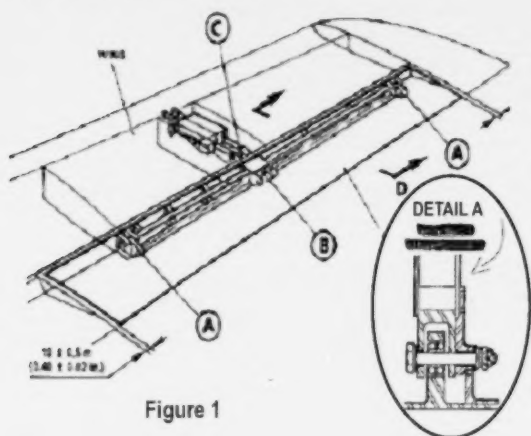
Aileron Flight Control Bolts

During the reinstallation of the LH aileron after maintenance, the engineer noticed that the aileron bolts, P/N 33412TX080041XA, at bearing #1 and #3 attach points, were installed incorrectly. The RH aileron bolts were checked and also found to be incorrectly installed. Both LH and RH aileron bolts were installed in the opposite direction of detail A. The bolts were removed, inspected and reinstalled IAW DA90 MM 57-511. (ref. Figure 1 detail A)

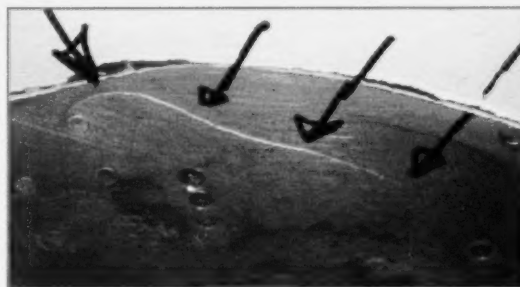
Crack Under Antenna

During an avionics upgrade, the forward ADF antenna was removed and the technician discovered a 3-inch crack in the fuselage skin.

The antenna had been incorrectly shimmed to the fuselage profile at a previous time. A second ADF antenna further aft on the belly was removed and the skin inspected with no damage found, although that antenna was also shimmed.

The damage was removed and repaired with an external doubler, IAW the Learjet Structural Repair Manual (SRM) and specific guidance instructions from Learjet engineering.

Transport Canada recommends that a dedicated inspection task for any antenna installation be developed for structural damage or corrosion as part of the Instructions for Continuing Airworthiness. ✂

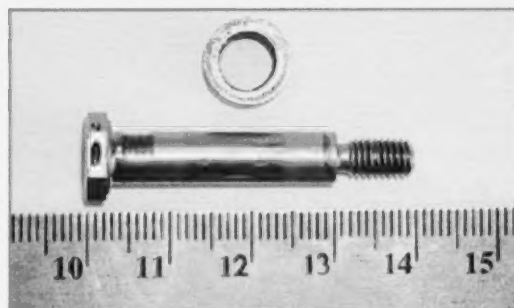
Rudder Attachment Bolts Worn

Play was discovered in the rudder upper attachment point of this aircraft. After inspecting the area, the submitter replaced; bolt P/N NAS1161-3-17, bearing P/N 940.83.28.506 and bushing, P/N 941.20.31.550 due to wear.

The aircraft had Pilatus ECE-TM-02-327 incorporated approximately 1000 hours earlier that provide a longer bolt to prevent shanking.

Pilatus is reviewing this Service Bulletin and the cause of the premature wear. ✂

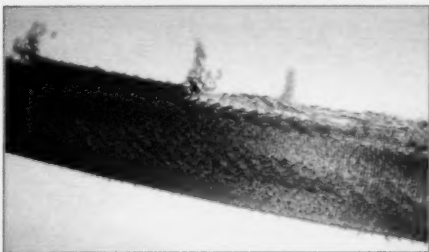
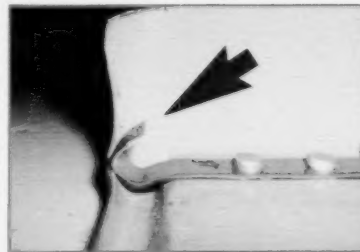
Shoulder Harness Frayed

The pilot seat belt shoulder harness, P/N 504339401, was discovered frayed. The fraying occurred between the shoulder harness and a retaining bracket for the seatback cover.

This defect was caused by the retraction and extension of the shoulder harness inertia reel over a period of two months and several flights. The bracket in question had sharp edges, and normally is not installed in this condition. The bracket also had a larger radius on one of the two brackets used for holding the pilot's seatback cover.

The submitter replaced the inertia reel assembly with a new unit and smoothed out the edges of the bracket. The submitter also added that they would be keeping a regular inspection of this area.✂

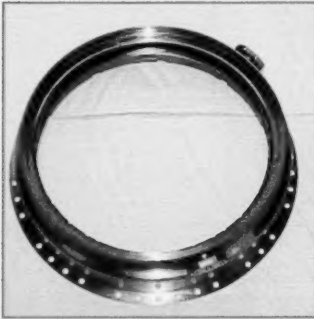
Carbon Seal

During rotation, the cabin crew reported smoke in the cabin, followed by a cockpit message indicating smoke in the lavatory. The cockpit crew noticed smoke, immediately donned oxygen masks and then de-pressurized the aircraft. Shortly thereafter, the pilot received a cargo smoke message and immediately discharged the cargo fire-extinguishing bottles.

Maintenance personnel traced the problem to a severe oil leak on the No.2 engine and observed displacement of the #1 Bearing oil seal retaining spring located at the #1 oil seal retaining ring. Further investigation revealed the carbon seal, P/N STA6270B, had failed.

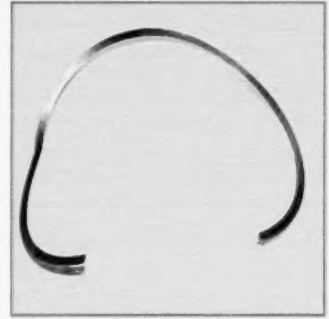
Retaining Ring

Radial carbon seals define the forward and aft limits of the three sump areas in which the main engine bearings are located. These carbon seals are pressurized by 7th stage compressor bleed air, which is greatly reduced to approximately 15 psi. The first sign of oil vapors in the cabin could be due to undesirable leakage of lubricating oil past any of the carbon seals. ✖

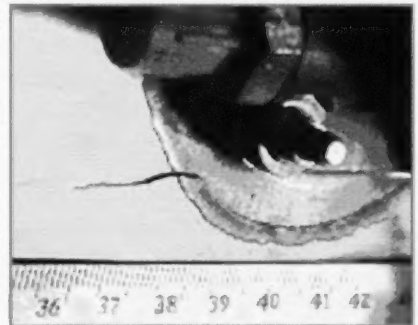
Combustion Chamber Case (Plenum) Cracked

During troubleshooting, maintenance personnel discovered that the combustion case plenum was cracked at the customer bleed air (P3) service flange.

An SDR search revealed two previous combustion case cracks on this series engine. Both these SDRs stated that a faulty 2nd stage compressor impeller had caused damaging vibrations that resulted in the fracture of the combustion case. Another SDR received from a different operator stated that overtightening the anti-ice valve during installation could overstress the weld area at the P3 service port and initiate cracking of the plenum case. ✖

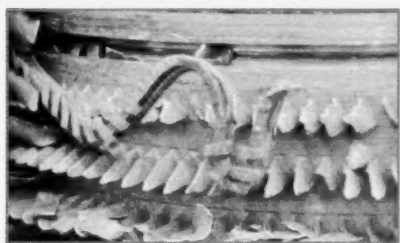
The engine manufacturer carried out an engine teardown investigation and discovered the root cause of this event was due to the complete detachment of the stage 7 disc rim of the high pressure compressor (HPC). Due to the rotation of the HPC, the detached disc rim was squeezed together and subsequently caused severe damage to all the adjacent blades on HPC stages 8, 9 & 10, which were found broken. Additionally, HPC stages 11 & 12 were found completely destroyed with only the remains of the blade platforms visible. Evidence of a titanium fire was also found

on the side of the HPC case. Heavy secondary downstream damage was also evident on the low pressure (LPT) and high pressure (HPT) turbine blades and vanes.

High Pressure Compressor Stage 7 - Disc

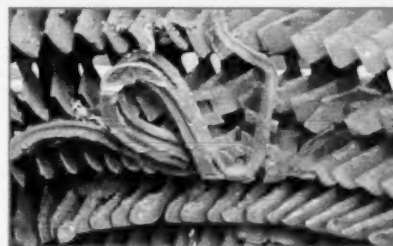
High Pressure Compressor Disc Rim

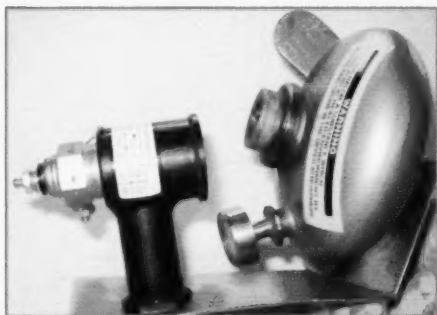
SDR # 20050506002 & 20050506012

APU Fire Extinguishers Inadvertent Discharge

During a routine inspection, maintenance personnel discovered that the APU fire extinguisher bottle was reading 0 PSI.

An investigation, carried out by the operator to determine the cause of this discrepancy, revealed that, if the APU fire warning test button was double tapped or held too long; it is possible to activate and deplete the APU fire bottle. The operator has been in contact with the manufacturer with respect to this incident. Upon removal, it was found that the fire bottle had separated from the discharge nozzle.

Another operator of a Learjet 45 discovered the APU fire bottle had discharged. The fire bottle outlet valve flange nut was broken and the fire bottle support bracket was bent causing the bottle to separate from the outlet valve.

Learjet has recently issued Advisory Wire 26-002 on this subject matter of APU fire extinguishers. It appears that inadvertent discharges have occurred during APU starting procedures. Advisory Wire can be found at www.cic.bombardier.com. ✖

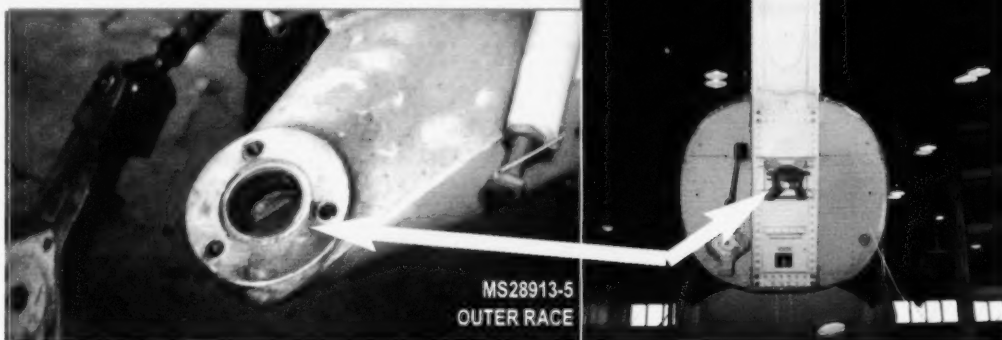
Rudder Hinge Failure

As the tail section was being inspected during a 4th phase 800-hour inspection, light rubbing and wear was noticed on the rudder hinge structure points. Also noted was that the rudder appeared to be sitting lower than normal on its hinges.

A thorough inspection of the rudder and its structure was carried out which revealed that the lower hinge point bearing, P/N MS28913-5, had completely disintegrated allowing the rudder to drop down. Parts of the bearing were found in the tail cone and the only thing remaining in the hinge was the bearing outer race. Light corrosion was evident once the bearing race was removed.

The FAA has been notified of this occurrence. The submitter noted that there is no lubrication or corrosion control required in this area as per Chapter 12 of the aircrafts maintenance manual. ✖

The hinge point damaged area was cleaned and inspected before the bearing was replaced with a serviceable unit.
